NaturalPaving Case Study Stabilization of Utility Access Roads and Pads

Project Background

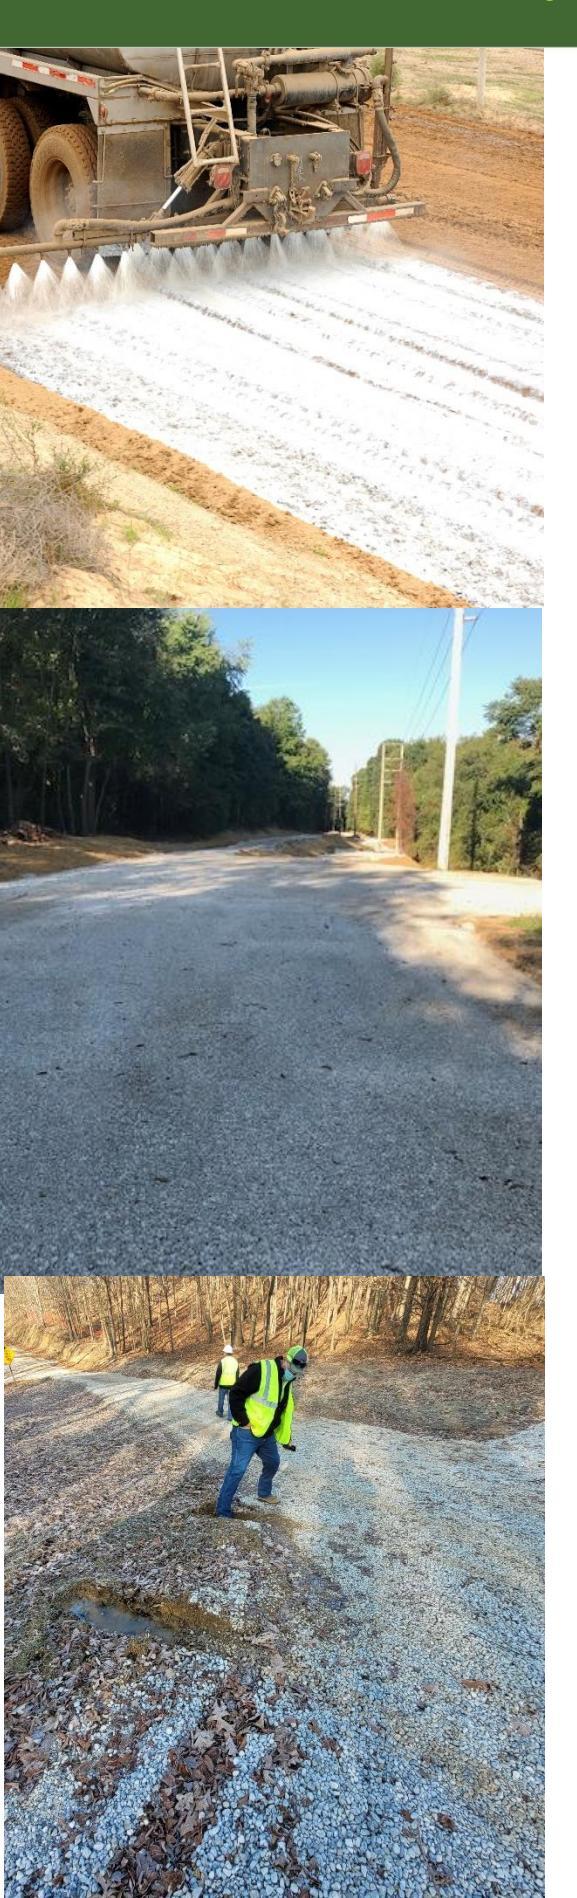
The utility company was very satisfied with the outcome and were able to perform all their work without issues or concerns about the integrity of the stabilized road and pads. To demonstrate the effectiveness of the SSEF89PBc stabilization, the photo on the left shows where a heavy truck went off the stabilized area and immediately sank almost 12" into the native soil. Without a quality stabilization design and installation, the utility company would not have been able to perform their needed work.

After the contractor performed their initial earthwork and shaped the roads and pads, SSEF89PBc was applied and incorporated into the upper 6" of the newly cut surfaces. In areas that couldn't be reached by truck, SSEF89PBc was carefully hand sprayed to ensure a uniform application. The SSEF89PBc treated surfaces were immediately graded to the design profile and compacted. Following compaction, the surface was not trafficked for several days to allow the SSEF89PBc treated layer to begin the curing process. Before the curing process was complete, a 1" thick layer of #57 stone was evenly spread on the treated surfaces and compacted to create an embedded aggregate wear course for all-weather friction. The surfaces were finished with a topcoat of Soil Sement Engineered Formula 69PBc to further lock the embedded aggregate into the surface.
