**Interim Report  
Soil Sement® Demonstration  
Kern County Road Shoulders**

San Joaquin Valley Air Pollution Control District

Larry Rennacker  
ArrowTek/Midwest Industrial Supply

November 7, 2003

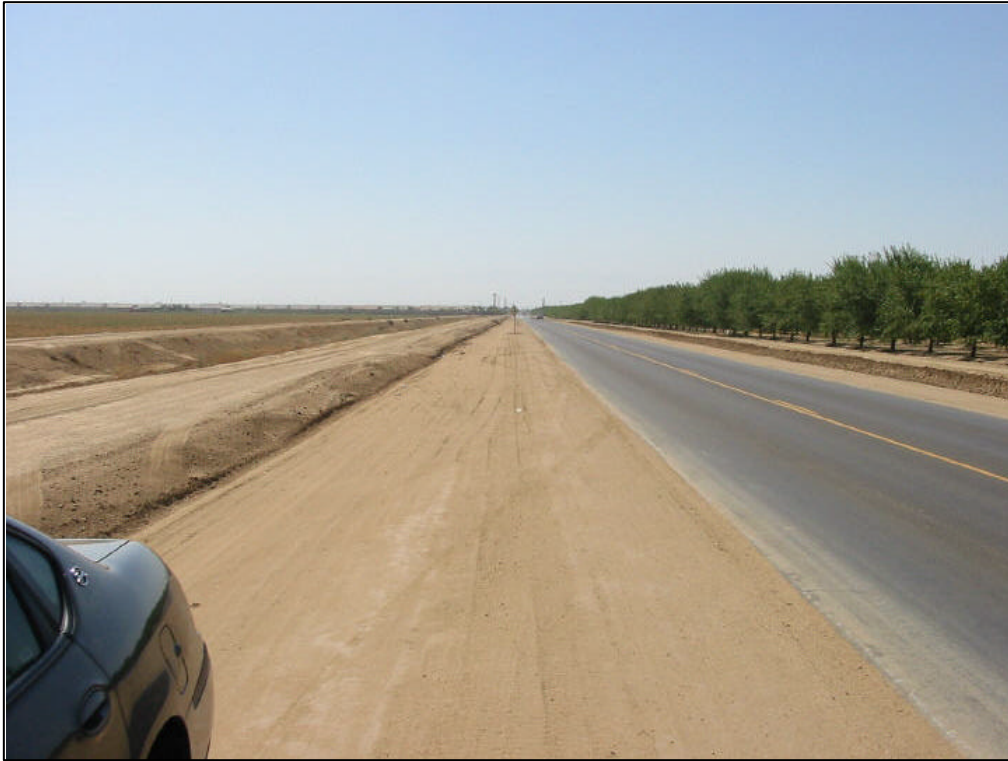
Photo 1  
Untreated Shoulder – Looking South on Allen Rd. between Snow and Kratzmeyer

The road locations identified by the Kern County Roads Department, application rates and costs are summarized in Table 2. Photo 1 illustrates the basic configuration and location of the unpaved shoulders. On September 21, 2003 Soil Sement® was applied topically using a computerized spray truck (see Photo 2). As indicated by Table 2, the demonstration included the evaluation of three different application rates.

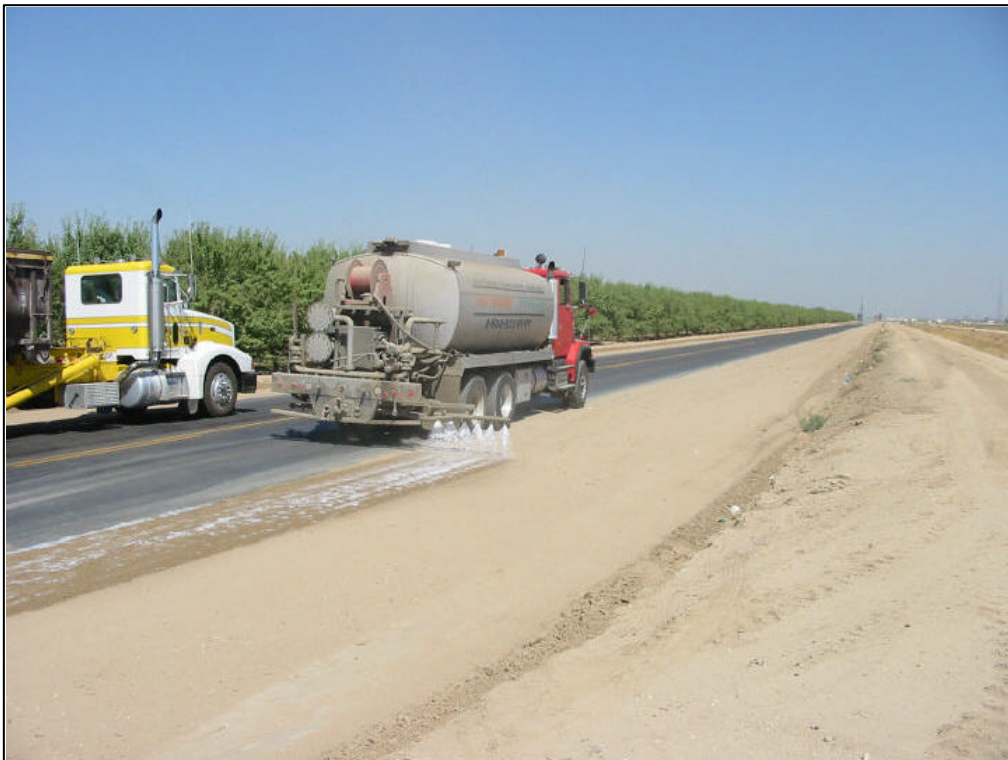
Photo 2  
Soil Sement – First Coat Looking North on Allen between Kratzmeyer and Snow

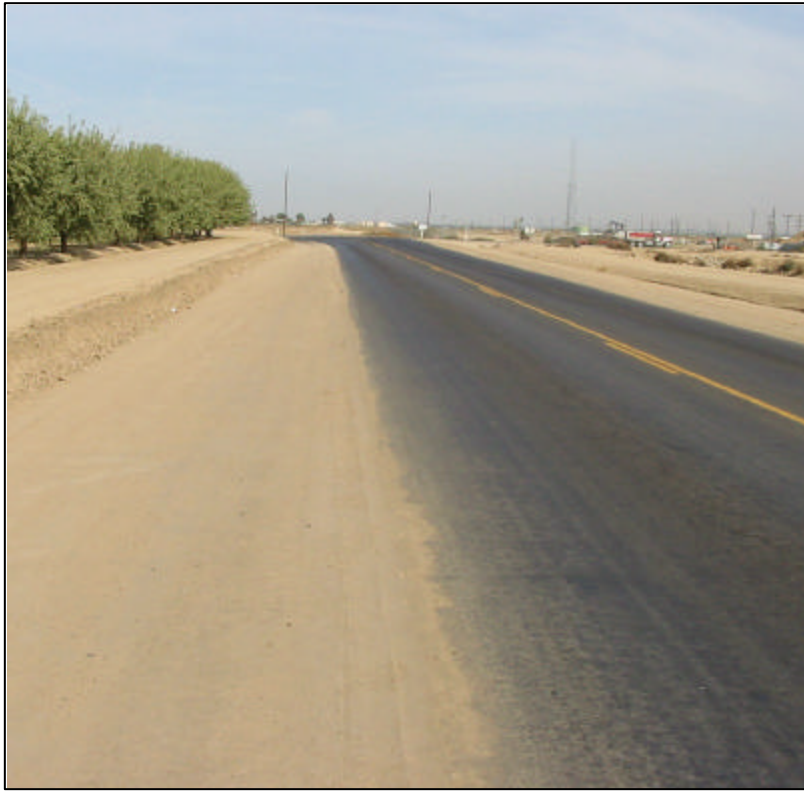
Photo 3  
Soil Sement® - Medium Application Rate Six Weeks After Application  
Looking North on Allen Road Between Kratzmeyer and Snow

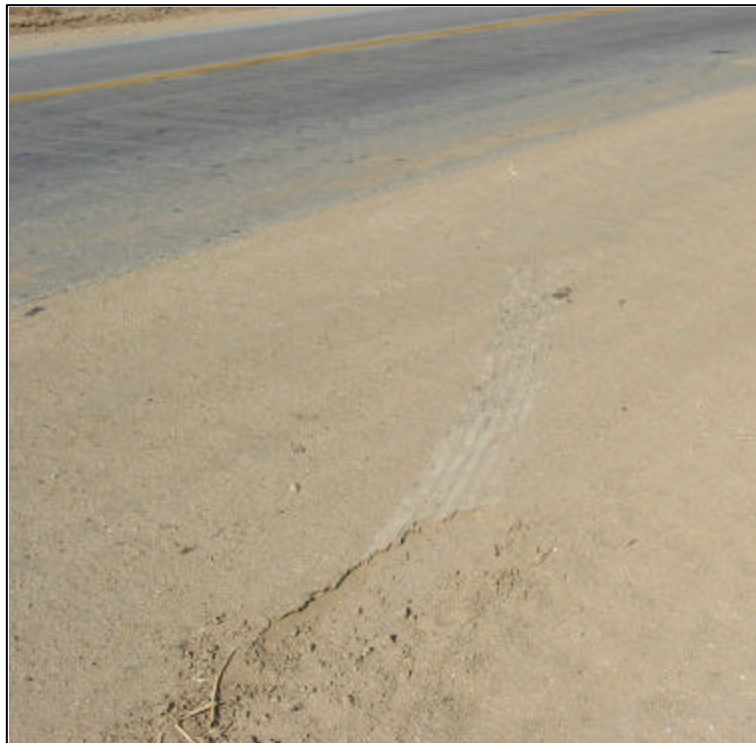
3. Soil Sement® provides a durable surface. See Photos 4 and 6 for an indication of performance and durability.
4. Agriculture and petroleum industry access are common in Kern County and cross county road shoulders. At these points fairly heavy-duty vehicles quickly stop or start while turning creating substantial stress on the shoulder surface (see Photo 5). This is a standard problem for all unpaved road shoulders regardless of the method of stabilization. In future applications Midwest suggests that transportation planning

Photo 4  
Demarcation Between Untreated Soil and Soil Sement®  
A Vehicle Used the Shoulder and Performed a Hard Acceleration

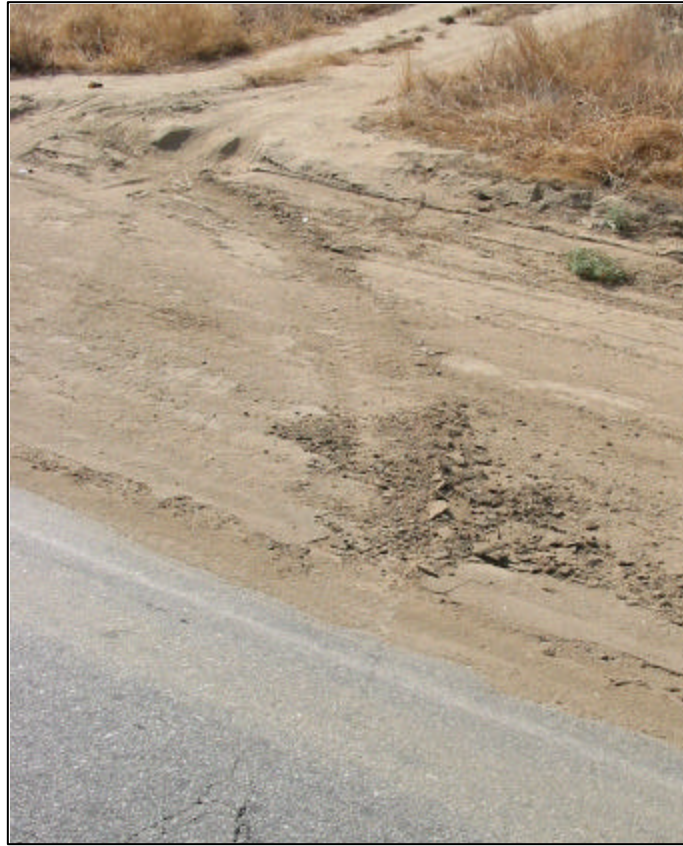
2. The medium and heavy-duty rates are withstanding shoulder traffic better than the light rate, which is expected. Kern County Roads staff indicated that they suspected vehicles tires had slipped off the road surface onto the shoulder and/or crossed the road shoulder to dirt access road in several places before the Soil Sement® had cured indicating a possible need to cone-off treatment areas for a short period for future applications (for example, see Photo 5).

Photo 5  
Damage to a Section of Soil Sement® Treated Shoulder  
Access Road to an Adjacent Oil Field  
Heavy-duty Weight with Significant Lateral Force and Braking

agencies consider stabilizing approximately 20 feet of the access road to help protect stabilized road shoulders.

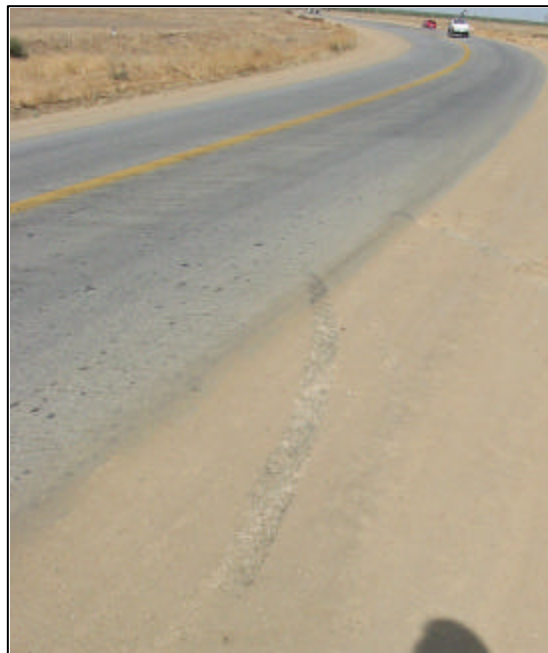
Photo 6  
Hard, Straight Acceleration on Soil Sement®

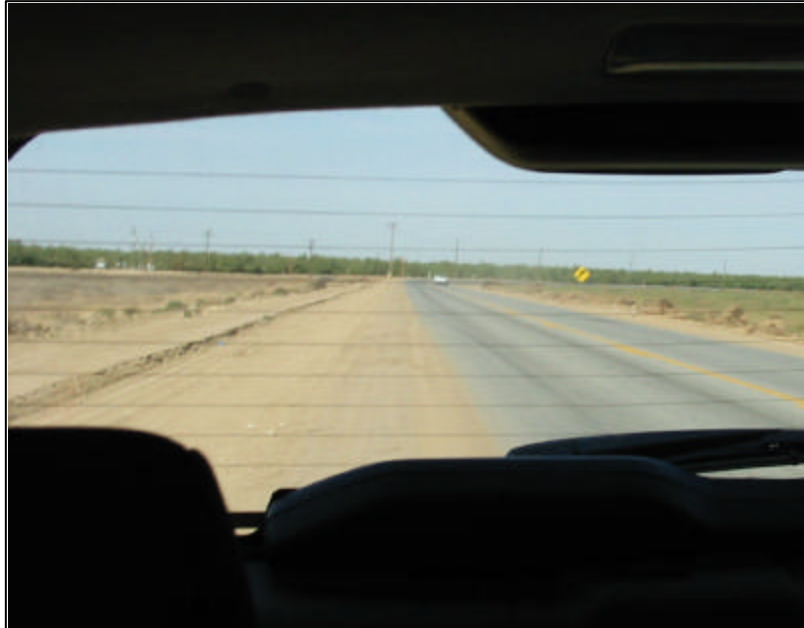
1. The Soil Sement® topical application has provided a hard stabilized surface and is effectively eliminating dust on the road shoulders (for example, see Photos 7 and 8). The after treatment photo was taken from a shoulder treated with the medium application rate.

Photo 7  
Shot Out of Rear Window at 40 mph on Soil Sement® Treated Shoulder  
Medium Application Rate on Allen between Snow and Seventh Standard Rd.

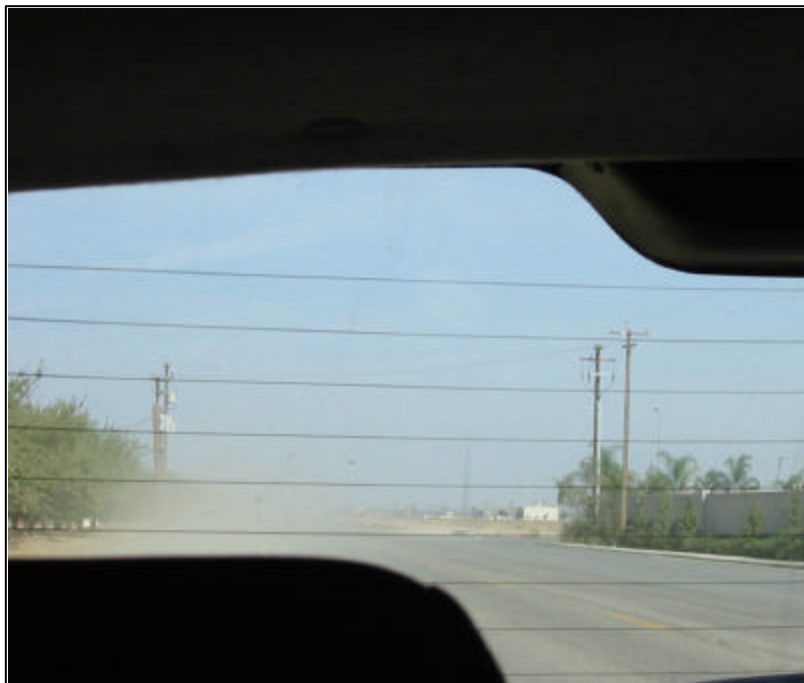
Photo 8  
Shot out of Rear Window on Untreated Shoulder at 40 mph  
Next Block South of Kratzmeyer on Allen
