FPL-GTR-154

Stabilized Engineered Wood Fiber for Accessible Playground Surfaces

Installation and Serviceability Results: Governor Nelson State Park, Wisconsin

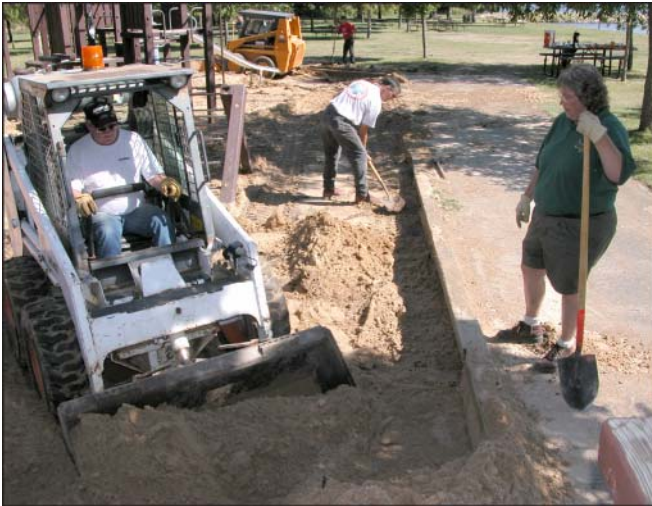
Figure 2—Removal of sand from existing playground surface.

Our efforts began by removing the existing sand surface to a depth of 0.38 m (15 in.) (Fig. 2). All roots, stones, and vegetation were removed. Much of the tonnage of sand was moved by two skid-steer loaders, but significant amount required handwork by a dedicated and hardworking volunteer crew from the Waunakee Rotary and a local chapter of Telephone Pioneers of America. The work crew also included employees of the park, the Wisconsin Department of Natural Resources, and the Forest Service. The majority of the clean sand was used to replenish the adjacent beach at the park and the remainder was piled in a wooded site nearby. Approximately 12 h of equipment time and 48 h of personnel time were required to remove the sand.

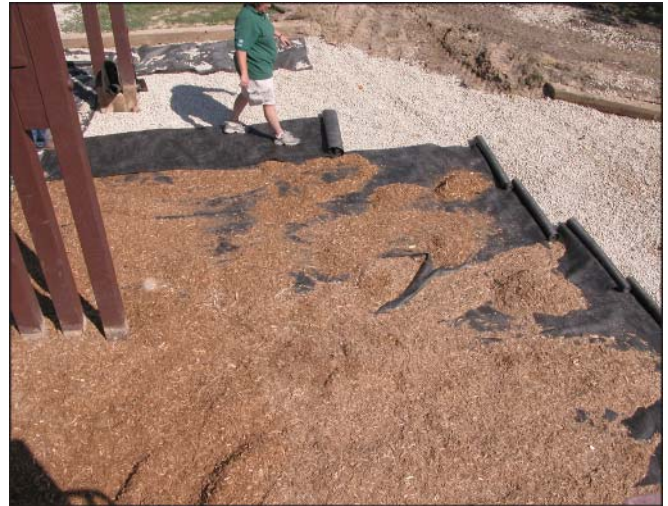
Figure 4—Completion of drainage system; second layer of fabric laid over drainage rock.

fabric was placed on the surface, followed by a 0.08-m (3-in.) layer of 18-mm (3/4-in.) washed, angular drainage rock (Fig. 3). Half the rock was placed using a skid-steer loader and the other half was placed manually using wheelbarrows. All the rock was shoveled and raked by hand to a uniform depth. Another layer of geotextile fabric was laid on top of the rock layer (Fig. 4). Handfuls of rock were thrown on the fabric to keep the wind from blowing it out of place. The layers of geotextile fabric kept soil and fiber from clogging the rock and thus preserved the drainage quality of the rock layer. Approximately 25 metric tons (28 tons) of rock was used. Placing the rock and geotextile required 25 h of manual labor and 3 h of skid-loader use.

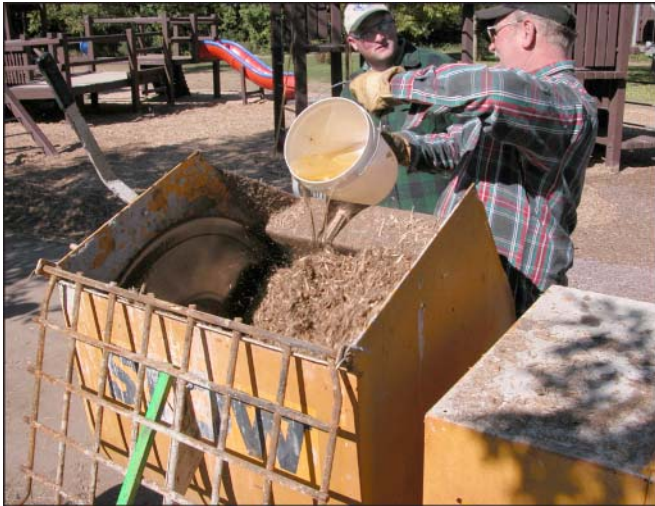
Figure 6—Mixing of binder and EWF in mortar mixer.

A portion of EWF was removed from the play area for stabilization. For the polyurethane binder, 38 mm (1-1/2 in.) of EWF was removed and for the emulsion polymer, 64 mm (2-1/2 in.) of EWF. The EWF was placed in a 160-L (40-gal) portable mortar mixer (Fig. 6). The amount of binder added was determined as a proportion (30%) of EWF dry weight (volumetrically equivalent to 0.041 m³, 1.45 ft³) to 5.3 L (1.25 gal) of Vitri-Turf or 10.6 L (2.5 gal) of Soil-Sement. Weight proportion was 77:23. The EWF and binder were mixed for approximately 3 min. The mixture was transported by polyethylene tray wheelbarrows to the target pad and spread with hand tools to an even thickness (Fig. 7).

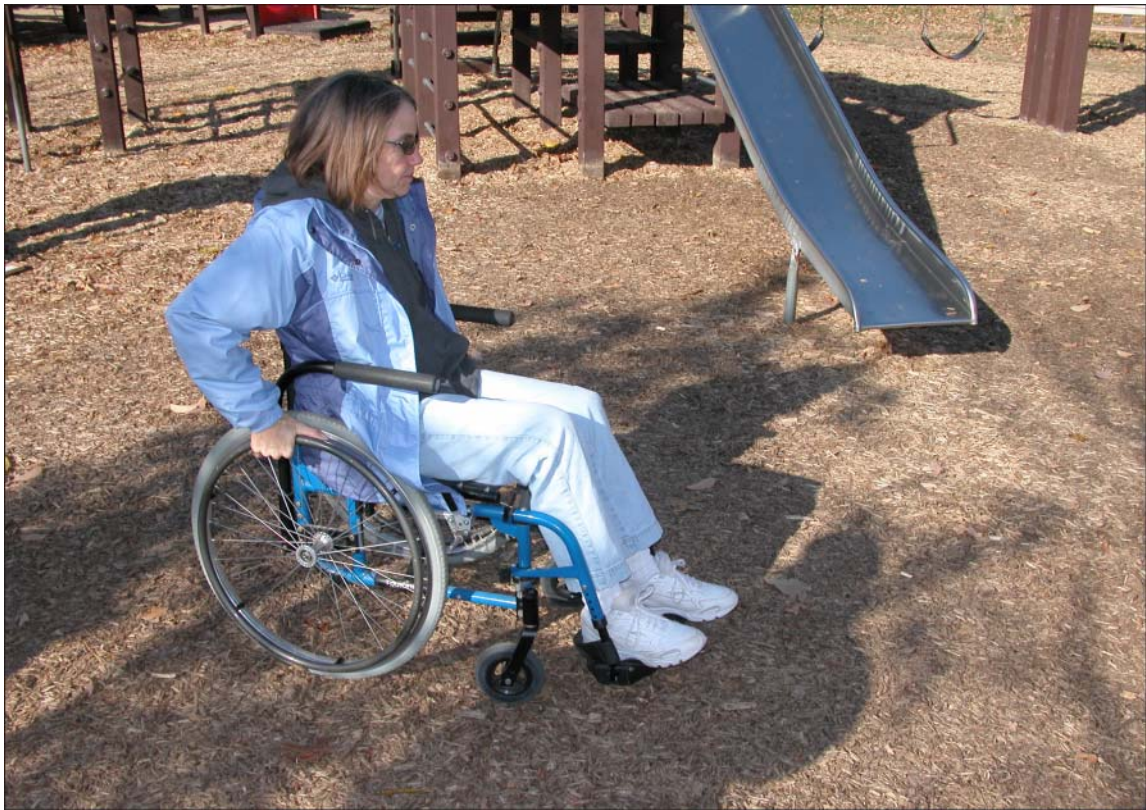
Figure 8—Completed playground looking north: left, Vitri-Turf SEWF; right, Soil-Sement SEWF; top, EWF. Line of demarcation is below wheelchair footrest.

The two SEWF surfaces were allowed to cure or bond for 6 days prior to usage. The entire surface was covered with polyethylene sheeting for 3 days to protect it from rain. Within 2 h of placing the Vitri-Turf, the surface was somewhat rigid to slight hand pressure. The Soil-Sement surface did not begin to cure or cross-link until more than 48 h had passed; when the polyethylene sheeting was removed, the surface was still slightly tacky. The area was left open to the air for another 3 days prior to opening the play surface for use. Figure 8 shows the completed surface, with little notable differences between the three surface materials.

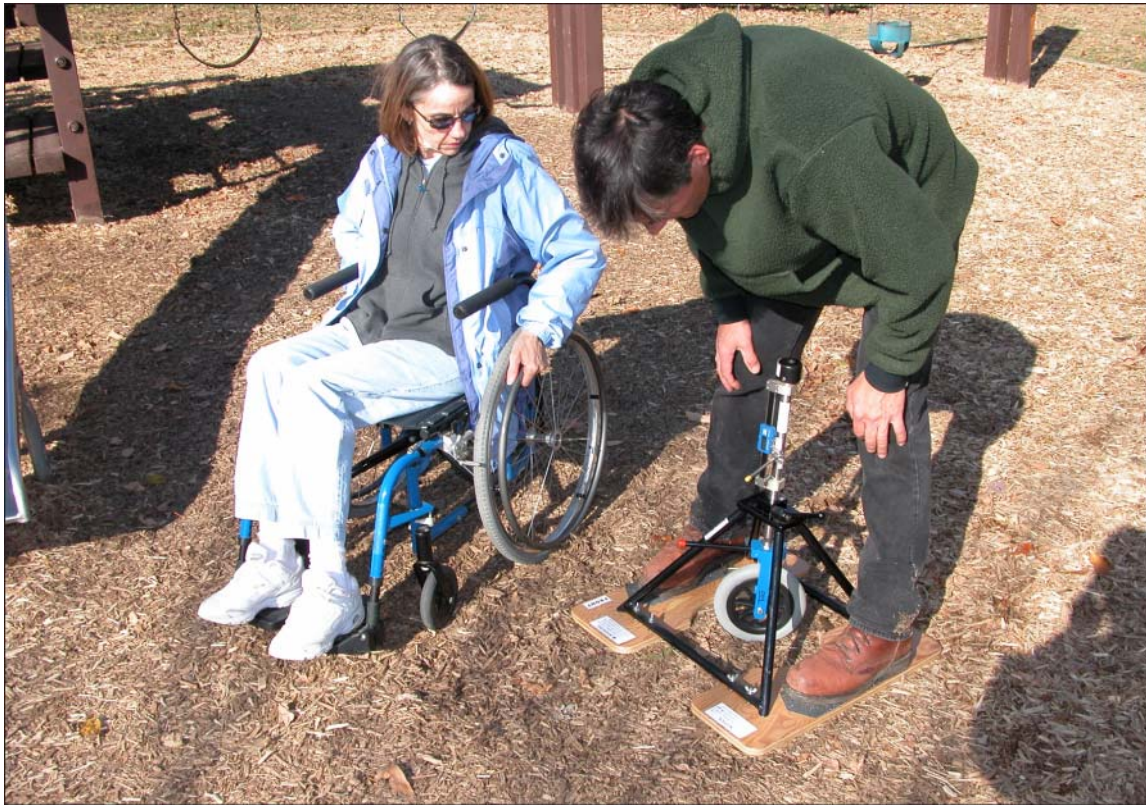
Figure 9—Measurement of accessibility with rotational penetrometer.

All surfaces were measured with the rotational penetrometer periodically over the first 6 months of exposure (Fig. 9). This device subjects the surface to a low-speed rotational bearing test that simulates the weight and action of a front caster wheel on a wheelchair. The procedures are based on a draft national standard test method for the firmness and stability of ground and floor surfaces (RESNA 2000), which uses an average of five readings. This test provides objective measures of surface firmness and stability and has been correlated to the work measurement of ASTM F1951, “Accessibility of Surface Systems,” for a wide array of surfacing and floor coverings (ASTM 1999b). The RESNA test was performed 1 week after surface installation and as often as once a week in the first 2 months, using the rotational penetrometer and protocol for assessing bearing/rotational surface indentation (Axelson and Chesney 1999). The device was used on test areas selected as representative of the entire surface.

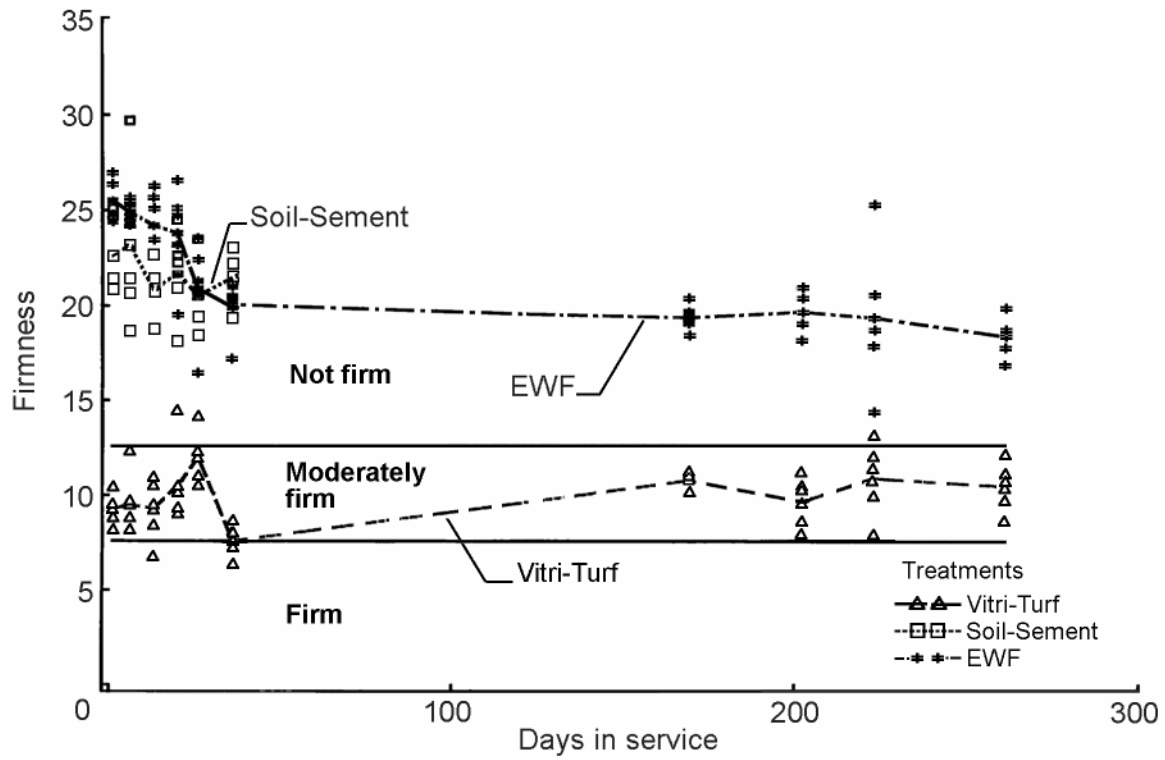
Figure 12—Firmness of playground surface, as measured by rotational penetrometer, over 9-month installation.

During the 10-month period of the test, firmness and stability of the SEWF surfaces were measured with the rotational penetrometer (Figs. 12 and 13, respectively). The Soil-Sement SEWF showed poor binding early in the exposure period, compared to the unsurfaced EWF. Only the Vitri-Turf SEWF showed acceptable performance for accessibility during the entire trial installation.

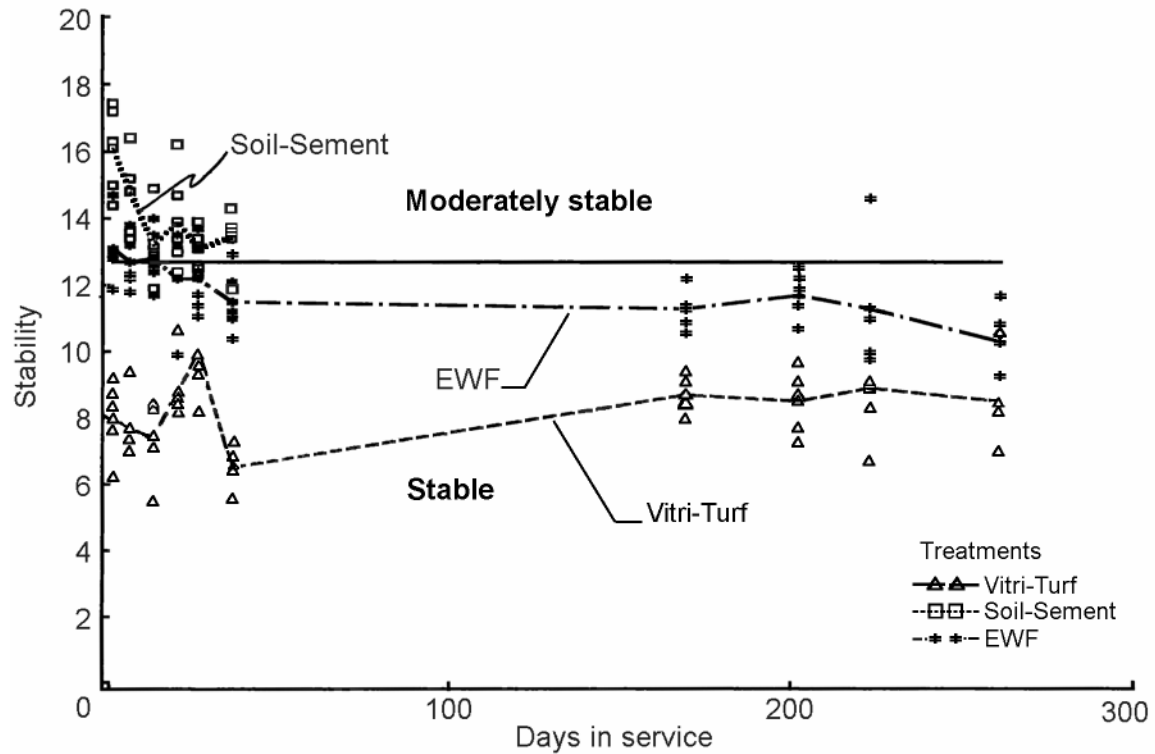
Figure 13—Stability of playground surface, as measured by rotational penetrometer, over 9-month installation.

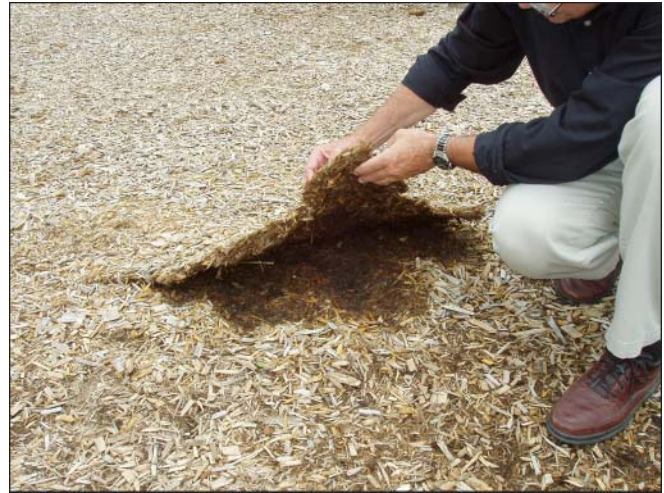
Figure 14—Exposed and torn edge of Vitri-Turf SEWF.

The durability of Vitri-Turf SEWF with exposure to weather was good and reflected similar experience with a prior exterior installation (Laufenberg and Winandy 2003). The integrity of the Vitri-Turf SEWF surface was maintained for the first 9 months. We then found that the edge of the Vitri-Turf SEWF had been lifted and the material torn off in large (0.2- to 0.8-m², 2- to 8-ft²) plates and tossed about on the play surface (Fig. 14). This damage occurred at the unprotected and unsecured interface with the unstabilized EWF. It did not occur at the edge of the playground where the Vitri-Turf had bonded to the wood landscape ties that surround the area. Differential settlement of the Vitri-Turf SEWF and the EWF (due to extensive rainfall) was approximately 38 mm (1.5 in.). As a result of the damage, the Vitri-Turf SEWF was removed 9 months after installation. The material showed little evidence of fungal propagation or insect infestation. The thickness of the removed material, measured at 24 locations, was an average of 30.4 mm (1.2 in.).
